PINPOINT
PROPERTY INSPECTIONS

Building Inspection Report

123 Sample Street, Perth, WA
Inspection prepared for: John Doe
Date of Inspection: 11/1/2015 Time: 11:00 AM
Weather: Fine
SAMPLE REPORT
Platinum Inspection

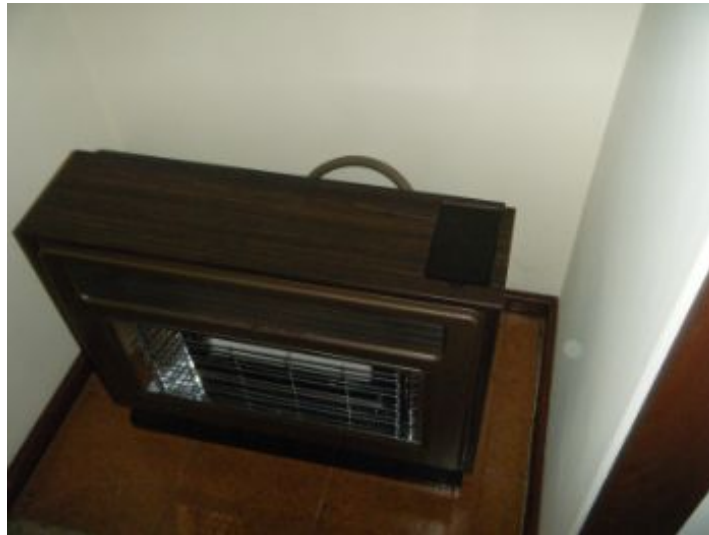
- A gas fired heater was noted. This was not tested as part of the inspection process and should be checked at the final pre-settlement inspection.

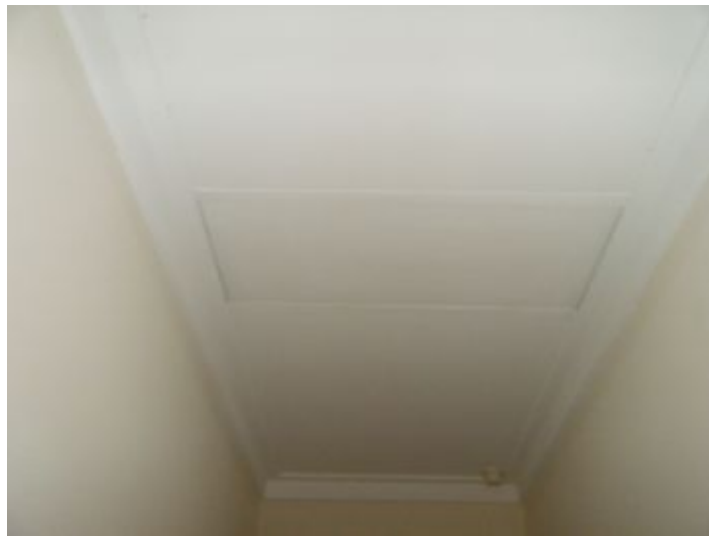
- Access was available through a manhole in the bedroom hallway.

- Limited visibility and access due to air-conditioner ductwork through out the ceiling space.

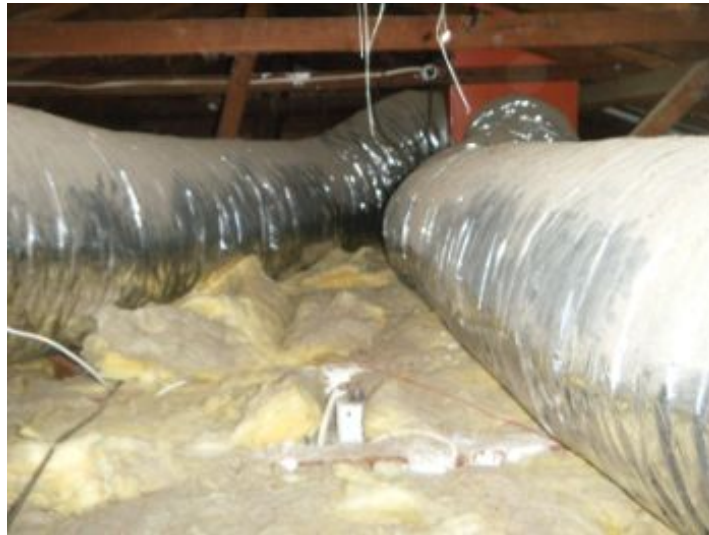
- Where visible, the air conditioning duct work appeared to be in a satisfactory condition.

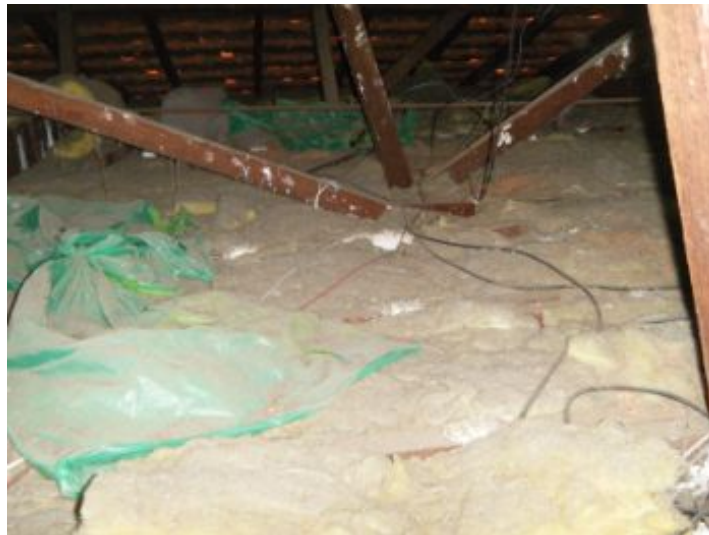
- Fibreglass batts insulation noted in the accessible ceiling space.

- Insulation averages about 100 to 125mm in depth.
- Insulation appears adequate.

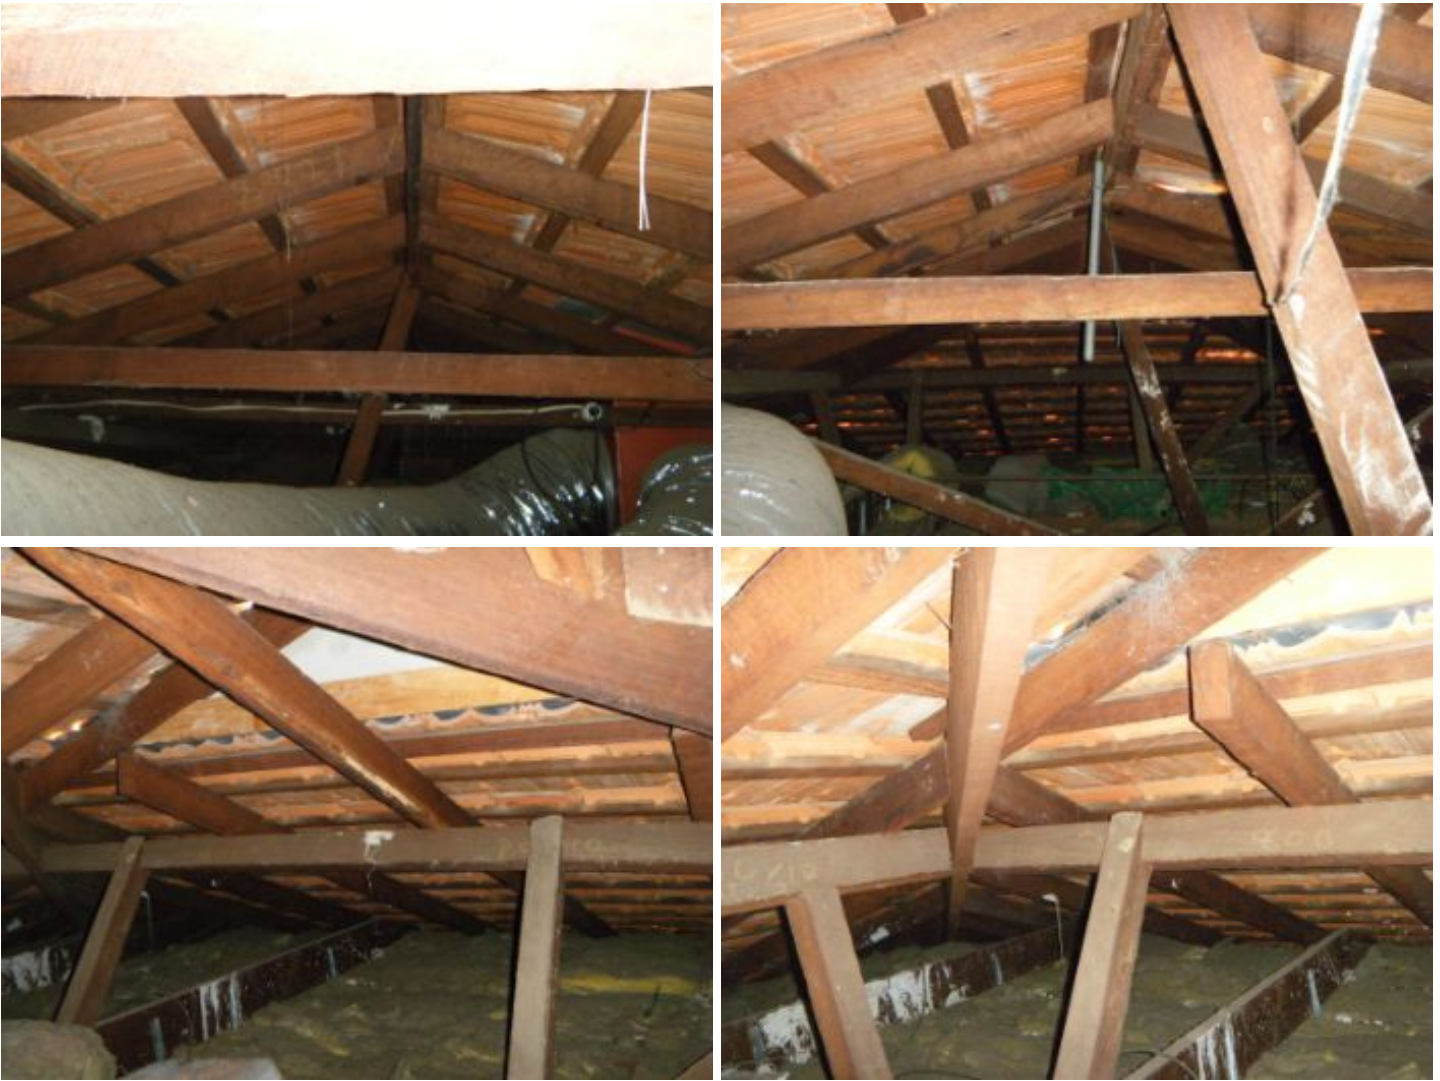
- The timber roof structure appears sound.

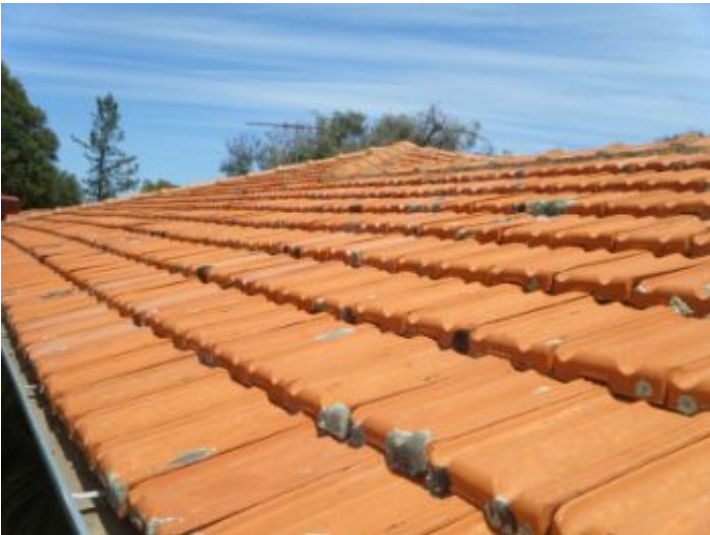
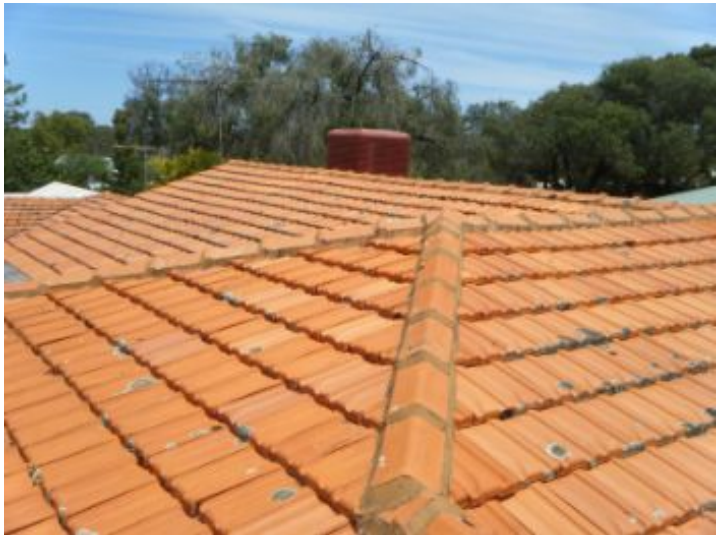
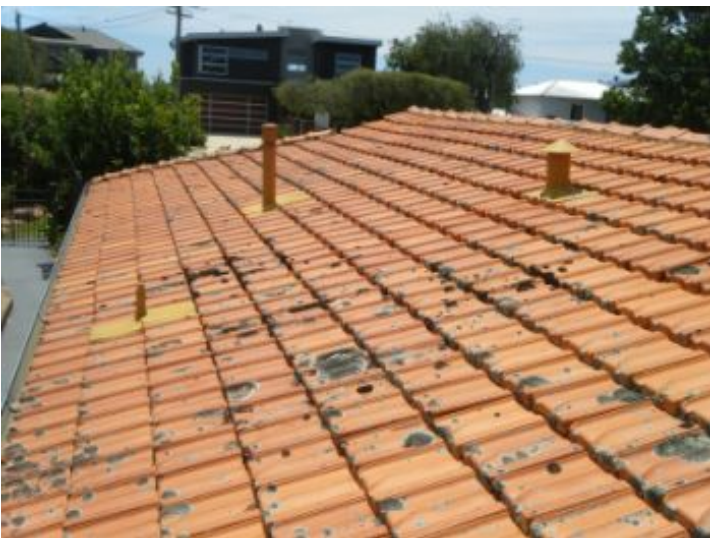
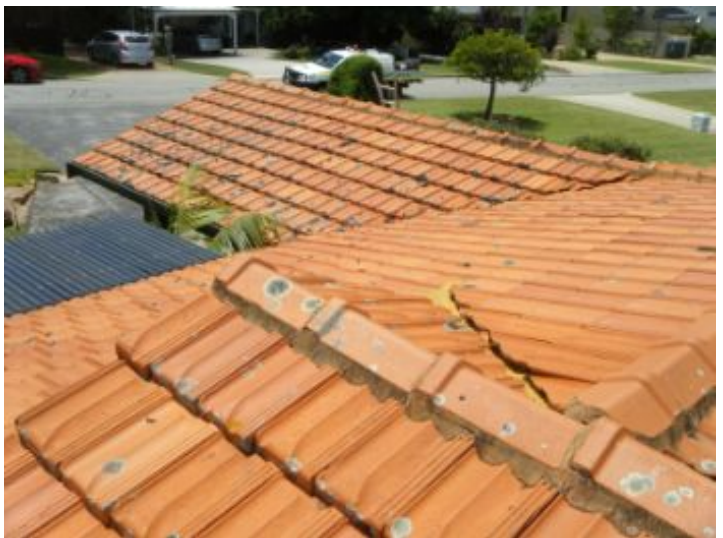
- The clay tile roof covering appears to be in satisfactory condition other than noted.

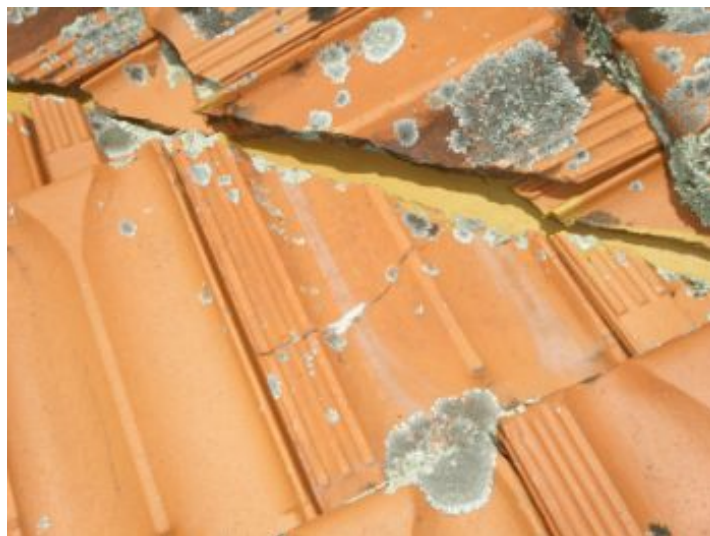
- There are several cracked or chipped tiles, but none of these appear to warrant replacement or repair of the tiles.

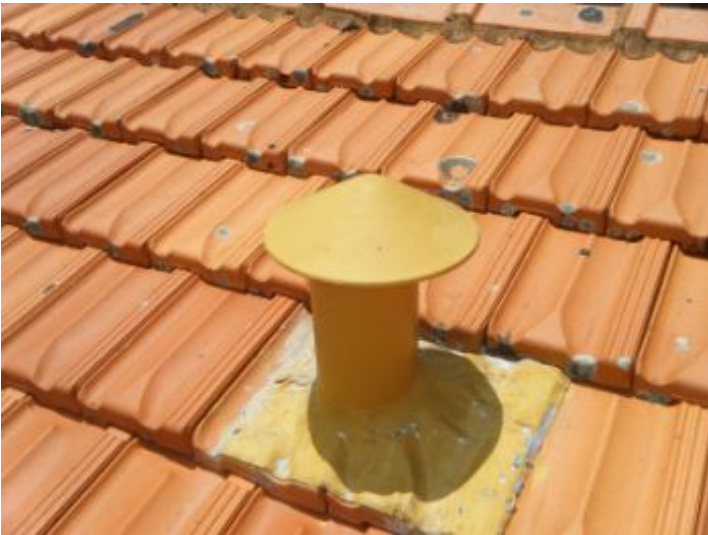
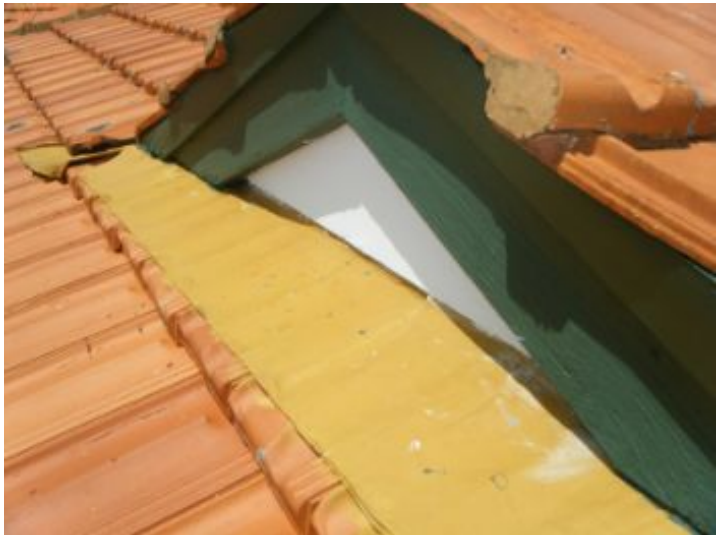
- Flashing is an impervious material (usually galvanized sheet metal) that comes in a variety of shapes and sizes and is used to cover, waterproof, and direct water away from roof penetrations and from valleys and intersections between the roof covering and other materials.
- The roof flashing, where visible, appears to be in satisfactory condition.

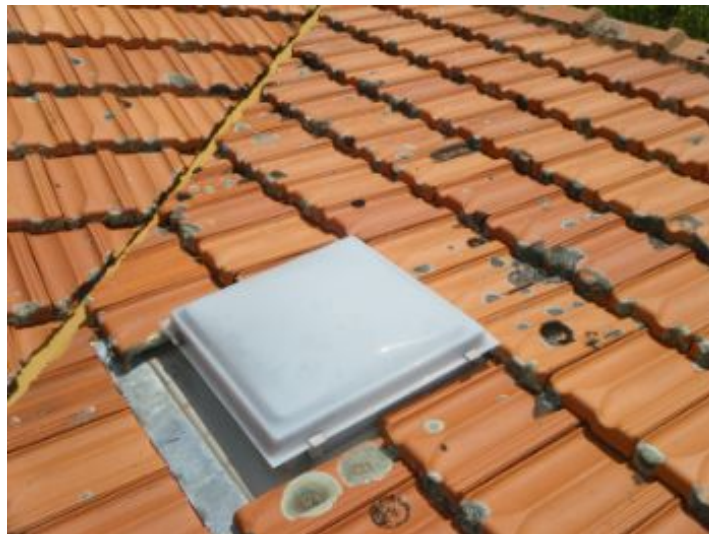
- No signs of present or past leaking around the skylight were discovered at time of inspection.

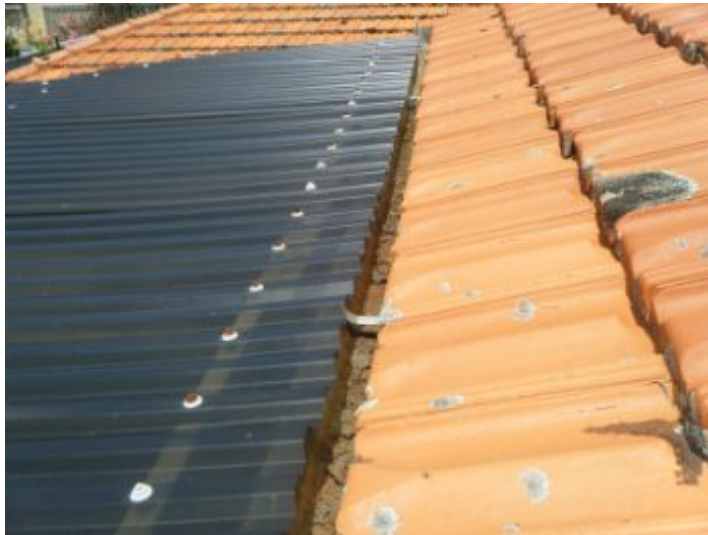
- No major function concerns noted at time of inspection.
- The gutters should be regularly cleared of debris to ensure the proper flow of water from the roof.

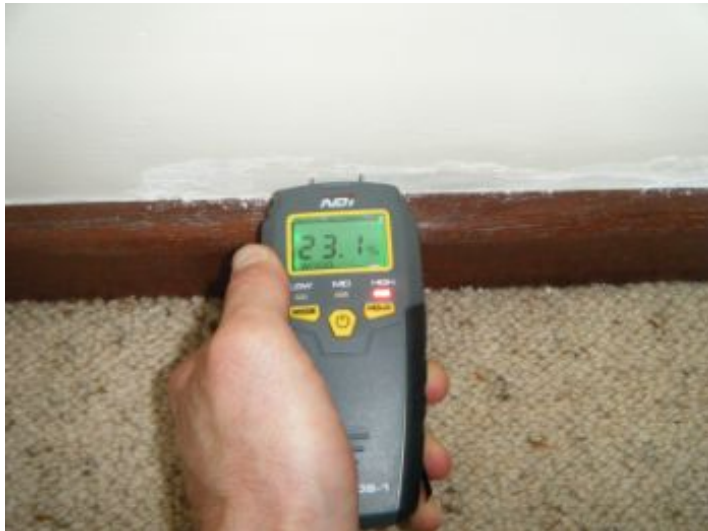
- There is evidence of dampness in the wall which is adjacent to the main shower. This is most likely as a result of the seals and tile joints not functioning correctly. The tiles and joints should be checked for leaks and resealed to prevent any further dampness. Then the wall should be allowed to dry out fully before being sanded/repainted as required. This does not appear to have affected the structural integrity of the wall.

Moisture reading

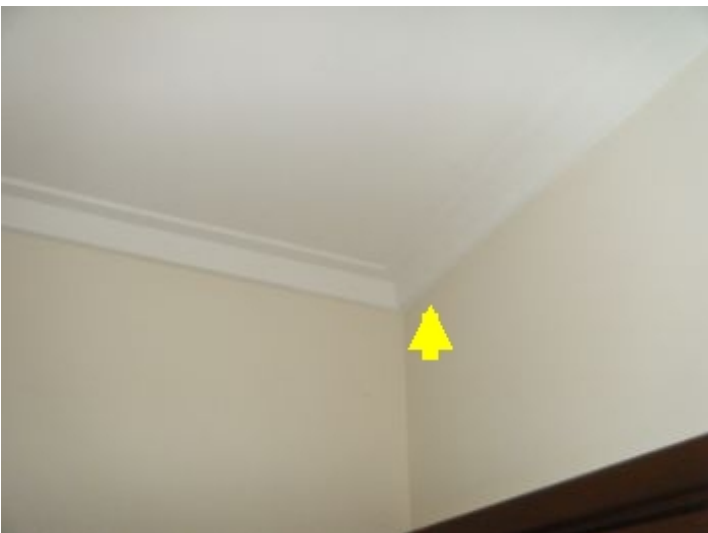
- There is minor cracking which has occurred at the interface between the ceiling cornice and the wall at various locations. This can be a result of foundation settlement and/or movement in the roof structure. This does not appear to have affected the structural integrity of the home and can be repaired normally.

Cornice cracking

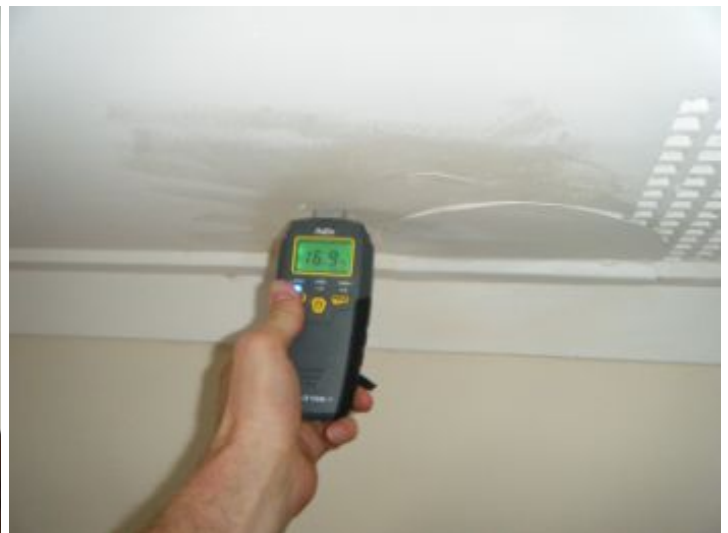
- There is what appears to be old water stains in the laundry and bedroom ceiling covering. Testing with the moisture meter did not indicate any current moisture present. Inspection within the roof space and of the roof covering did not reveal an obvious source of any leak, which is difficult to detect when it is not raining. We did however note that the roof pitch is relatively shallow. This coupled with a tiled roof structure sometimes allows wind blown rain to enter the roof space underneath the tiles which can result in some water stains at various locations within the home. This is usually not a serious problem as it happens infrequently, however, we suggest that you monitor this area during heavy rainfall to confirm whether any immediate maintenance work is required. This is important because our inspection does not warrant or guarantee the roof against leakage.

Old water stain

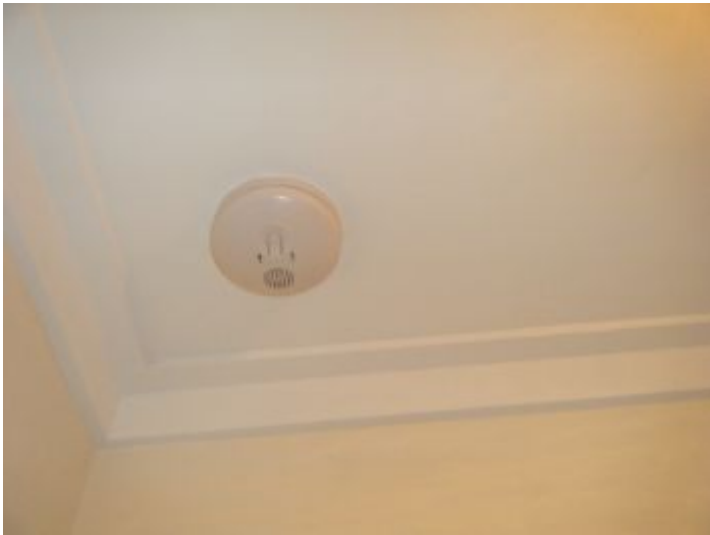
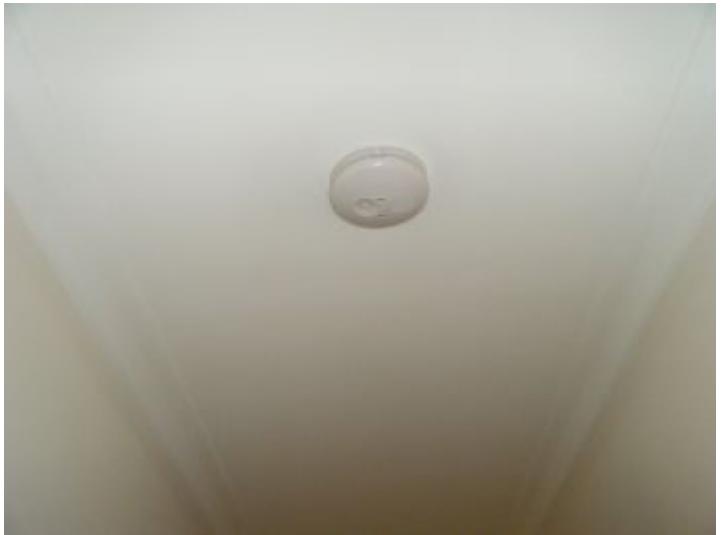
- Testing of smoke alarms is not included in this inspection. Pushing the "Test" button only verifies that there is power at the alarm--either a battery or hard wired to the house power--and not the operational workings of the alarm. The operational check is done by filling the sensor with smoke and is beyond the scope of this inspection. Battery operated smoke alarms should be checked routinely and the batteries changed frequently.
- There are hard wired smoke alarms installed in the bedroom hallway and the entrance areas.

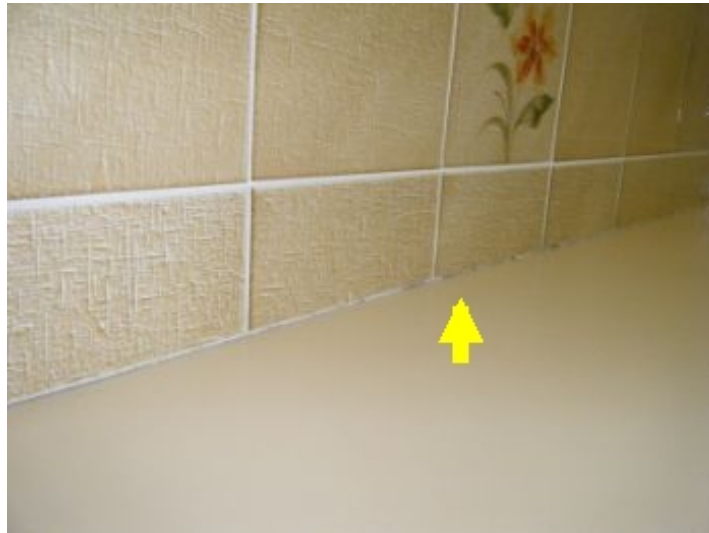
- No major discrepancies noted in the counter tops and surfaces. There is normal wear, consistent with their age.
- The gap between the counter and the wall requires sealing to prevent moisture intrusion into the cupboards.

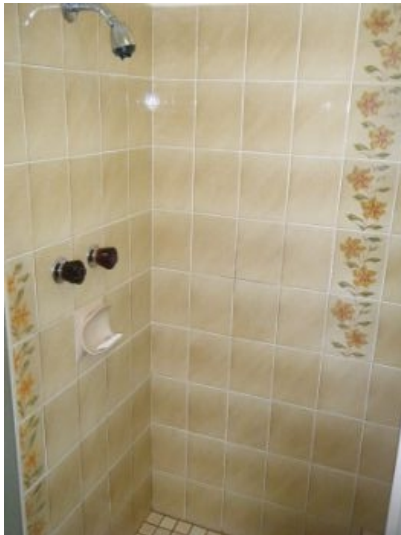
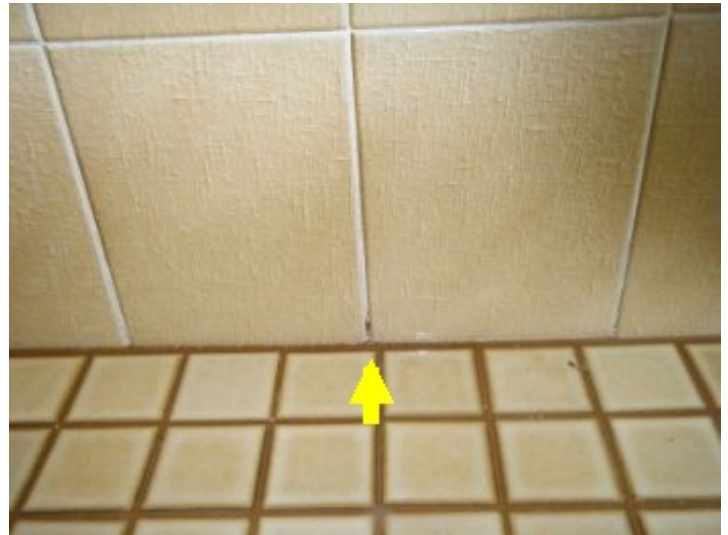
- As a preventative measure, we recommend sealing tile grout and joints to prevent water infiltration into walls.

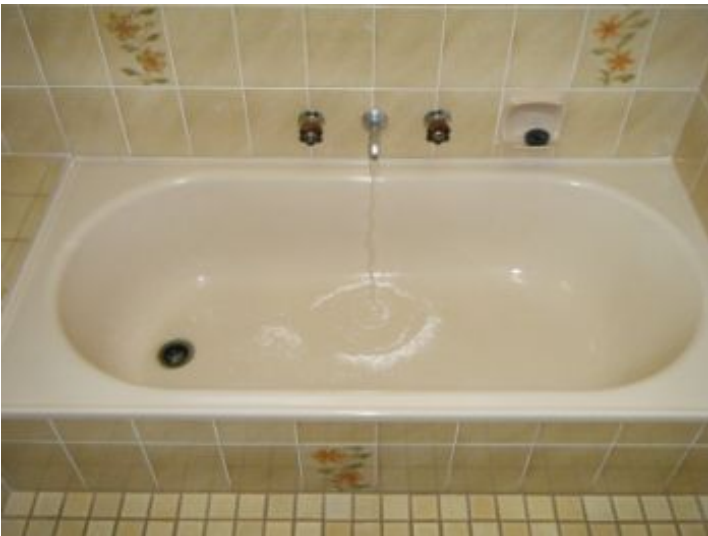
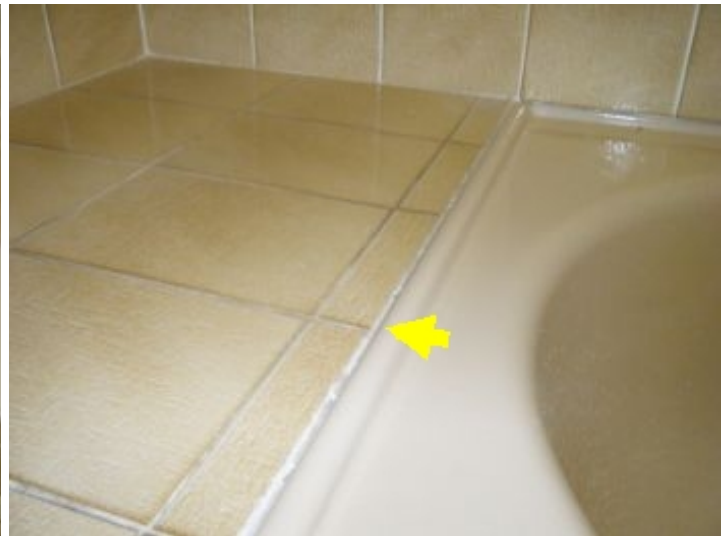
- The bath tub and related components operated normally when tested.
- The gap between the bath and the wall tiles requires sealing to prevent moisture intrusion into the wall.

Requires sealing

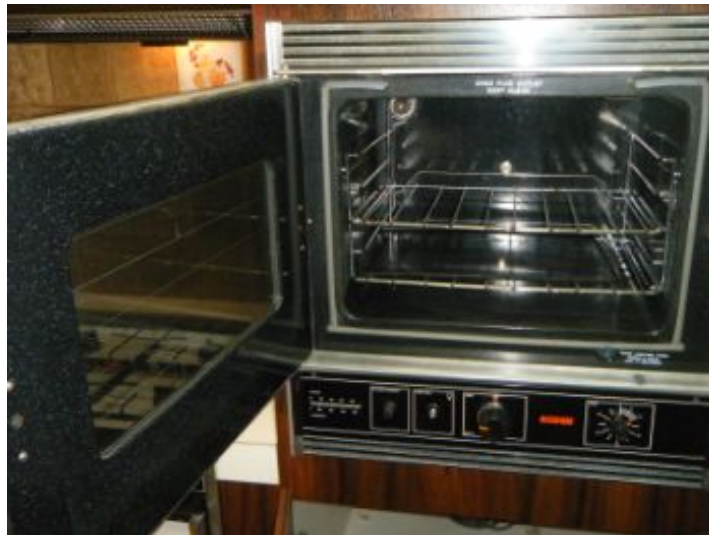
- The gas oven was tested at the time of inspection and appeared to function properly.
- The oven light did not function when tested. Replace bulb and retest at the final walkthrough inspection.

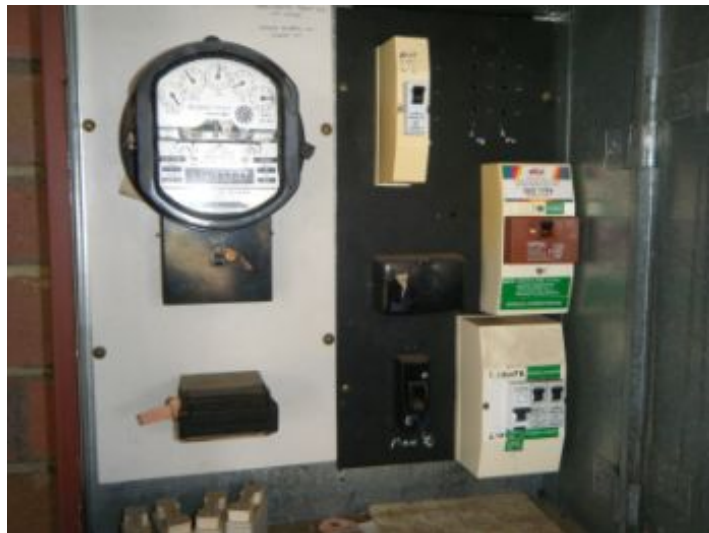
- Main Panel Location:
- Exterior of structure
- North side of the house.

- One RCD (Safety Switch) has been installed. In line with the latest regulations another RCD safety switch is required to be installed prior to settlement. This is required to be carried out by the vendors.

Electrical		
Page 22 Item: 1	Electrical Panel	<ul style="list-style-type: none">• One RCD (Safety Switch) has been installed. In line with the latest regulations another RCD safety switch is required to be installed prior to settlement. This is required to be carried out by the vendors.

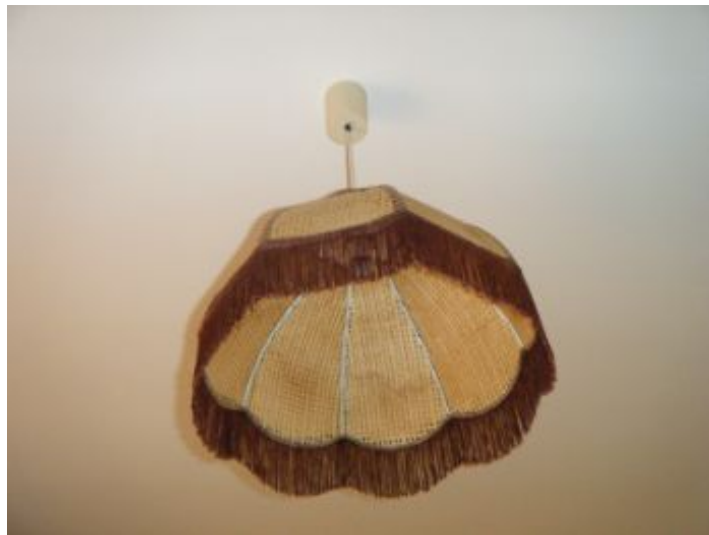
- There is a light fitting located in the rear bedroom that did not have a bulb installed at the time of the inspection. This should be fitted with a new bulb and tested prior to final settlement.

No bulb

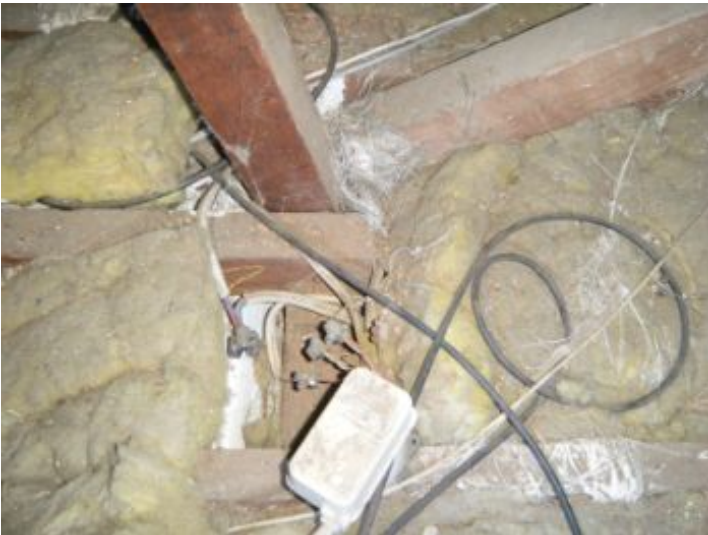
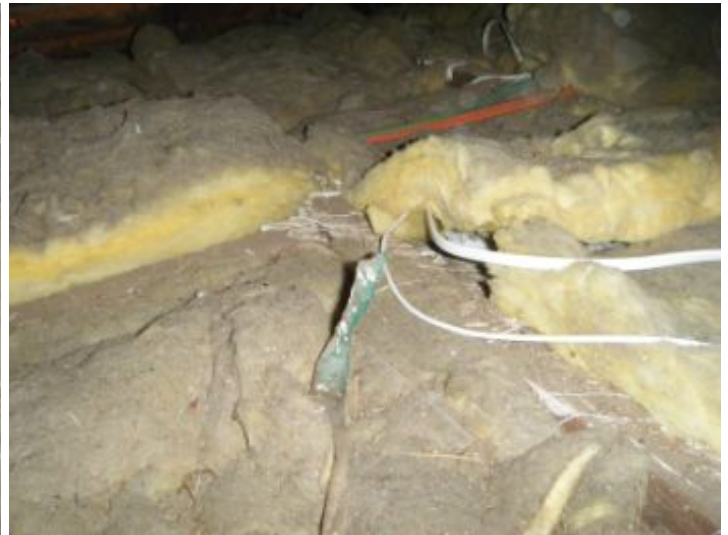
- There are electrical terminations not contained in a junction box in the roof space it is recommended that these be capped and contained within a covered junction box for safety.

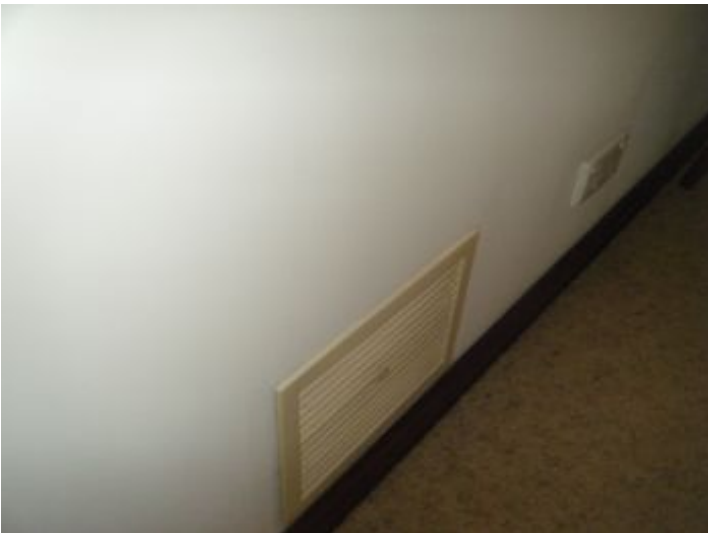
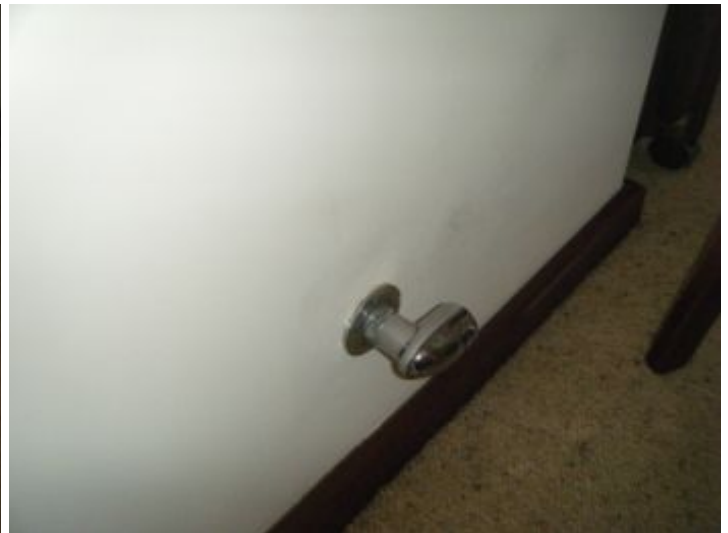
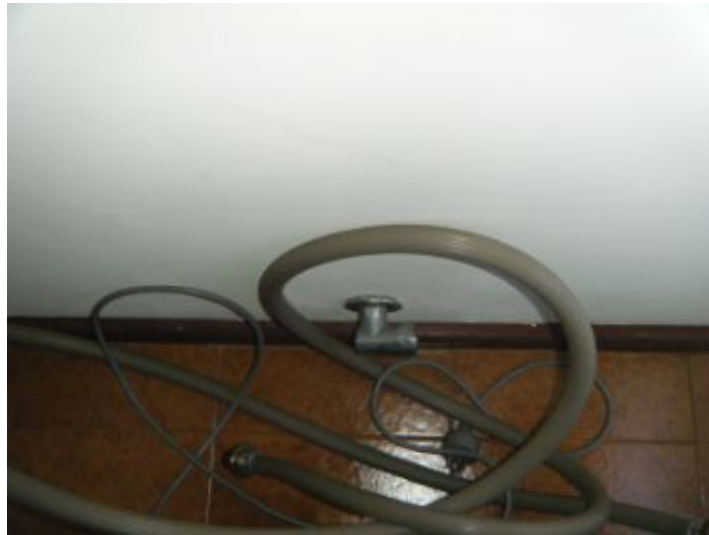
- Gas bayonets installed. No wall or ceiling vent observed. Location of these bayonets are: lounge room and dining room.

- There are ceiling vents (high vent) but no low vents installed in the lounge area. If you intend to use an unflued gas heater you may want to consider installing a low vent to aid ventilation.

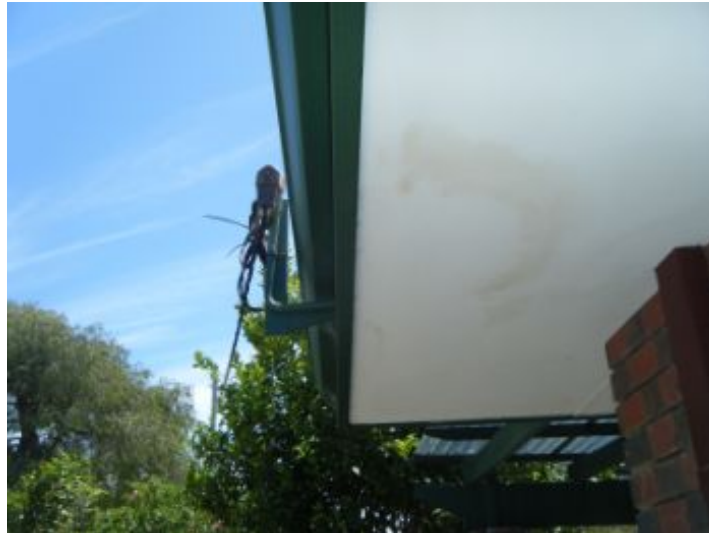
- The eaves are in satisfactory condition other than noted.
- Fascia covering the ends of rafter or truss tails appeared to be in generally serviceable condition at the time of the inspection. Notable exceptions will be listed in this report.
- Water stains were noted which is an indication that the gutters have likely overflowed in the past. Ensure that the gutters are kept clear of vegetation and other debris and that the downspouts and soakwells are functioning correctly.
- Some weathered timber noted. Recommend review for maintenance as required.

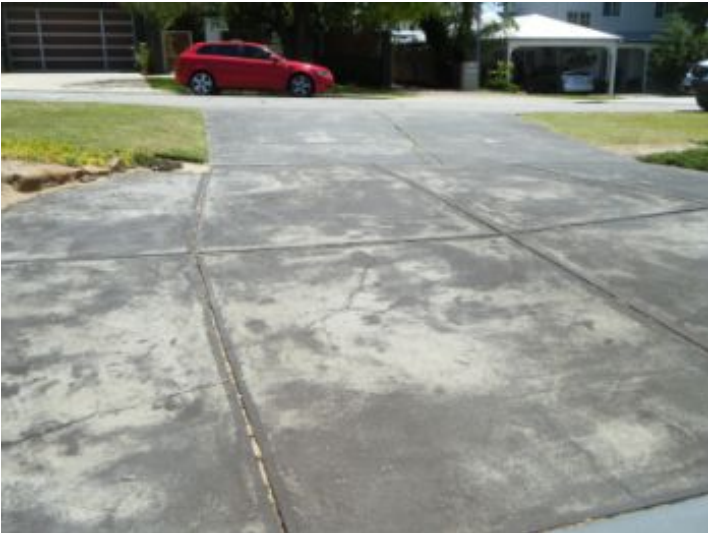
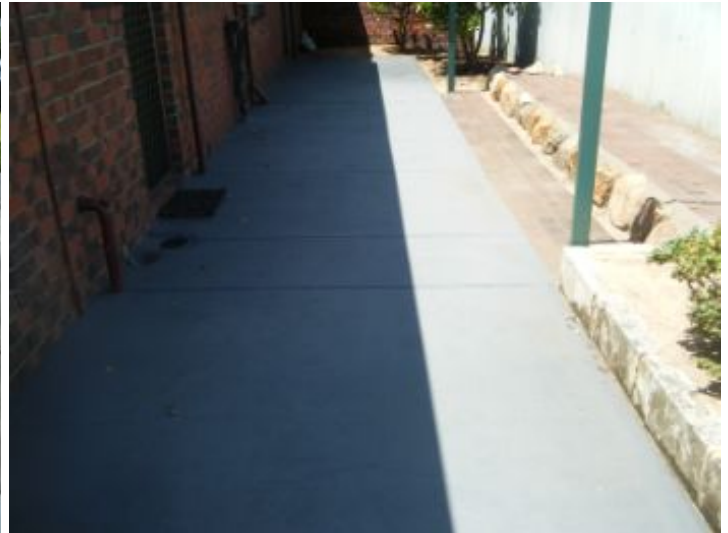
- Minor settlement or "hairline" cracks in driveways are normal to properties of any age. They should, however, be monitored for expansion and sealed as necessary.

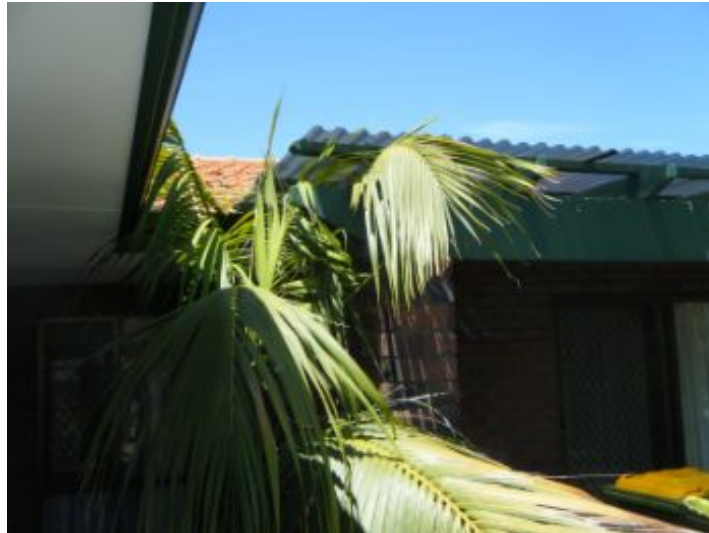
- Trees that begin to grow too close to or overhang property should be trimmed back; this will help reduce the frequency of having to clean out the gutters which should be done on a regular basis.
- Prune or remove any plants that are in contact or proximity to home to eliminate pathways of wood destroying insects.
- Tree limbs within 3m of roof should be trimmed away to provide air and sunlight to roof, while minimizing debris, dampness and abrasion damage.

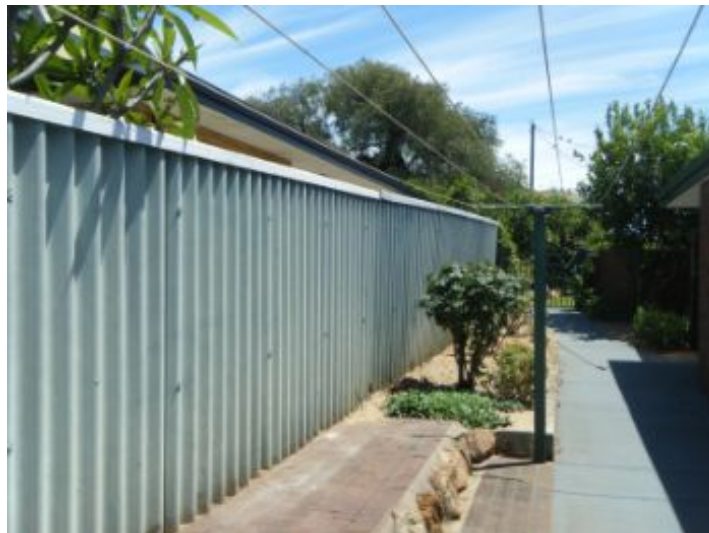
- Asbestos
- Unless otherwise noted, the perimeter fence appeared functional at the time of the inspection.

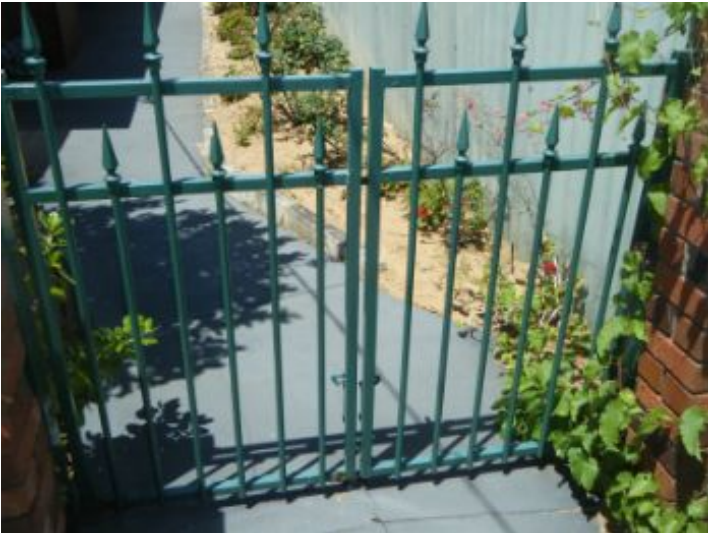
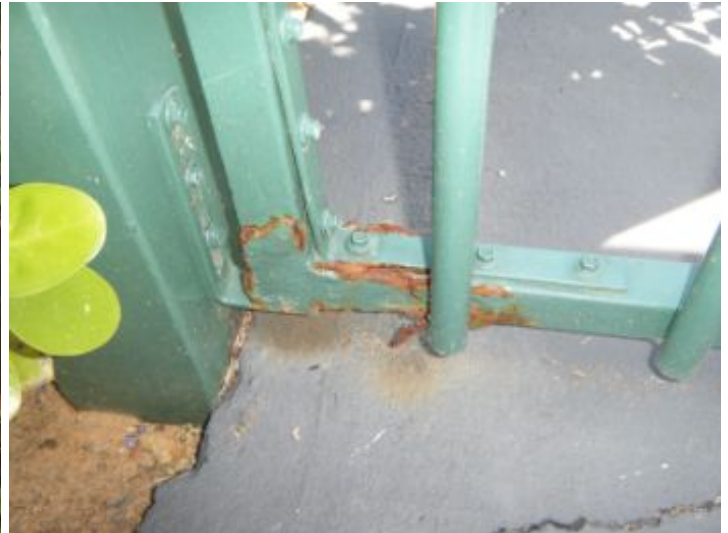
- Rust deterioration was noted to the metal gate. Recommend treating with a rust inhibitor and repainting to prevent further rust deterioration.
- The timber gate was locked at the time of the inspection and could not be opened.

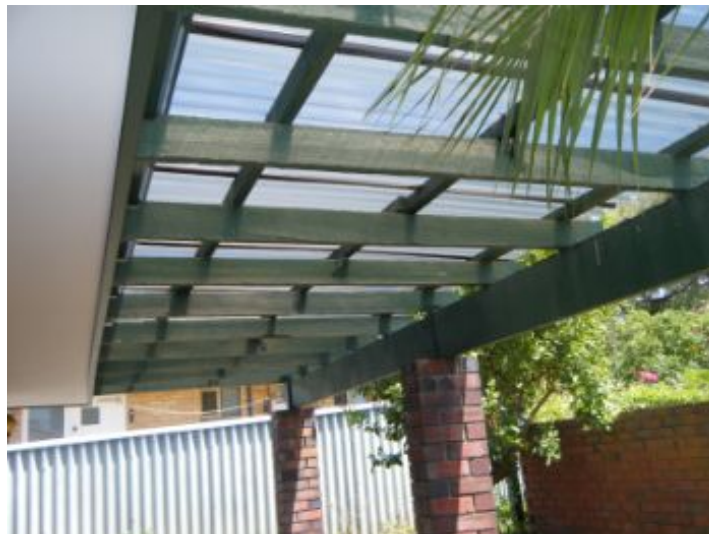
- No deficiencies noted. Appears to be structurally sound.

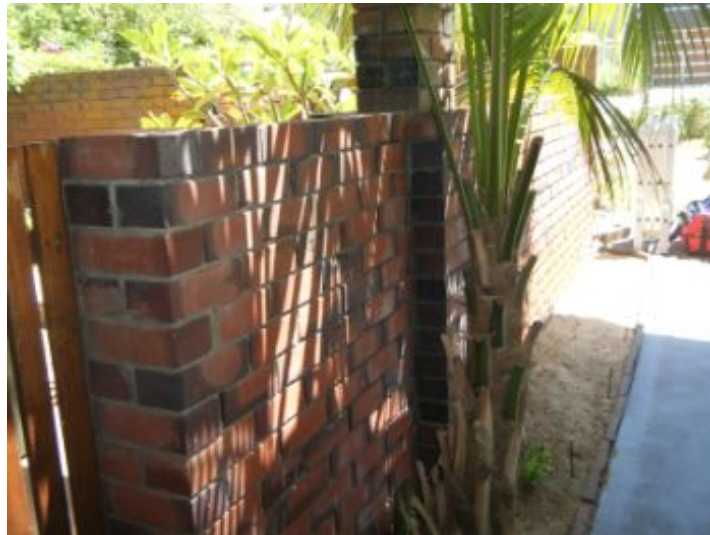
- The yard walls appear to be functional and structurally sound.
